AESSEAL® upgrade solution leads to an 8 year failure free period

Industry:	Metal Processing
Product:	CDSA and PUMPPAC™
Application:	Slurry Transfer Pump
MTBF Increase:	2300% (and counting)
Reference N.O:	CH00584

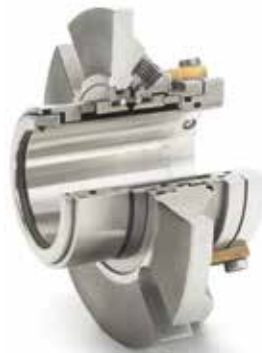
AESSEAL® installed a cartridge double seal (CDSA) and PUMPPAC™ forced lubrication support system. The PUMPPAC™ system was chosen because after investigating previous seal failures it was clear that the pressure of the plants water line was not consistent, leading to premature seal failure.

Since the upgrade, the AESSEAL® solution has been running trouble free for eight years, giving the customer a massive 2,300% mean time between failure increase. The CDSA and PUMPPAC™ solution has also eliminated expensive maintenance costs and the continuous production outages that occurred previously.
