Helping to keep the water flowing for South Australia

Industry:	Water & Waste
Product:	Cartridge Single Mixer Seal (CSM)
MTBF Increase:	4300% (and counting)
Savings:	\$41,250 AUD (and counting)
Reference N.O:	CH01165

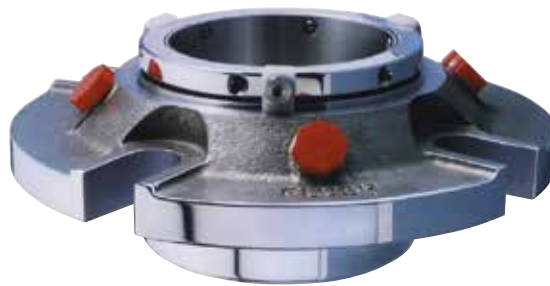
A remote pumping station in South Australia, 150 kilometres from the repair depot was having regular failures on their high pressure booster pump used to pump water through a South Australian pipeline.

The Gland Packing constantly needed adjusting and was causing sleeve wear, which was causing the pump to lose prime and suck air rather than water on start up. AESSEAL® installed a CSM seal to replace the Gland Packing, with a key consideration being reliability.

The CSM seal has been in place for 11 years and has not leaked once since installation. Due to the remote nature of the pumping station it was costing roughly \$1,250 per breakdown in costs, but as the pipeline supplies water to South Australia, downtime had more serious implications.
